## 1 5. The Planning of DOW Pipeline Reconstruction near the Estuary Areas of the Chi-Ben River in Taitung County of Taiwan

The purpose of this presentation is to discuss the planning and relevant engineering issues relating to the reconstruction of a deep ocean water (DOW) pipeline near the estuary areas of the Chi-Ben River in Taitung County of Taiwan. In 2012, the DOW pipeline constructed for the Eastern Taiwan Deep Sea Water Innovation & Research Center (ETDIC) collapsed after typhoon activity and has been unable to supply DOW since then, resulting in severe adverse effects to DOW industrial development in Eastern Taiwan. Due to the fact that ETDIC had been established and operated since 2009 by the Ministry of Economic Affairs (MOEA), and had played an important role for DOW development, MOEA has decided to reconstruct the pipeline. Currently, planning and execution are underway.

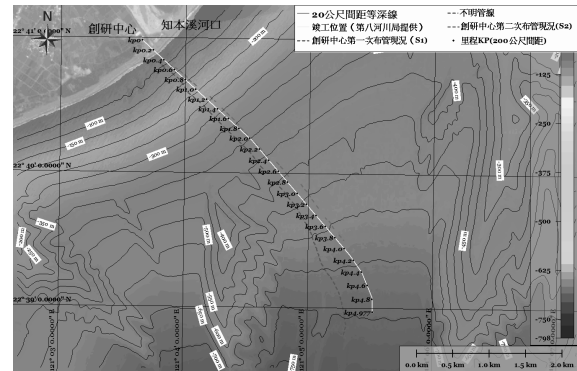
After a thorough investigation by the use of underwater acoustic instruments including side-scan sonar and the multi-beam system (shown in Figure 1) and/or remotely-operated vehicle (ROV), it has been concluded that the failure of the DOW pipeline was caused by the following two factors:

1. Environmental Factors: the large amount of sand and silt carried by the Chi-Ben River after the typhoon rain may have resulted in a large deposit and sediment movement beyond the safety factor set by the design limits.

Figure 1: Marine environment and changes near the estuary areas of the Chi-Ben River, conducted by the Agency of Water and Hydraulics of the Ministry of Economic Affairs (MOEA).
